INSTALLATION RESTORATION PROGRAM

PHASE I: RECORDS SEARCH

PLATTSBURGH AFB, NEW YORK

April 1985

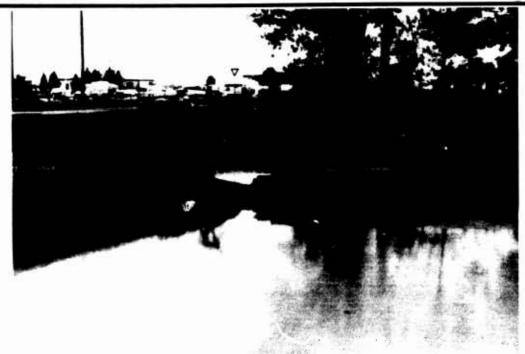
Flightline Drainage Retention Ponds 1 and 2 (view facing west)

Pond 2 is in foreground; Pond 1 in background. The drainage channel (above) and the first pond are connected by the culvert (on the left) beneath the road entering the golf course.

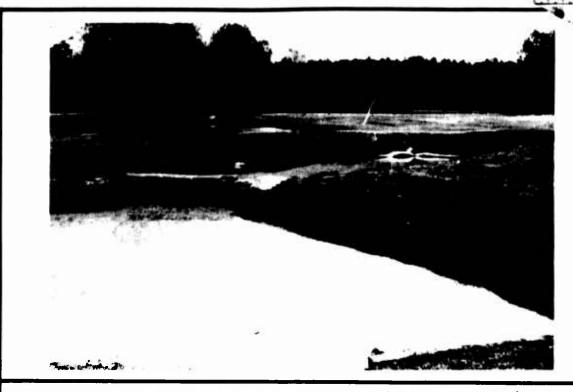
Flightline Drainage Retention Pond (view facing east)

First pond in foreground followed by second, and third pond in background. Note oil absorbent boom placed at discharge end of second pond.

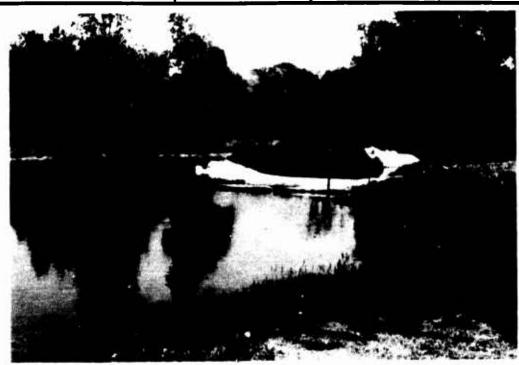
Industrial Drainage Retention Pond (view facing northeast)

Pond in foreground is first of two ponds treating drainage from industrial areas adjacent to flightline ramp. Second pond is visible beyond concrete dam. Note oil absorbent boom in place on concrete dam.

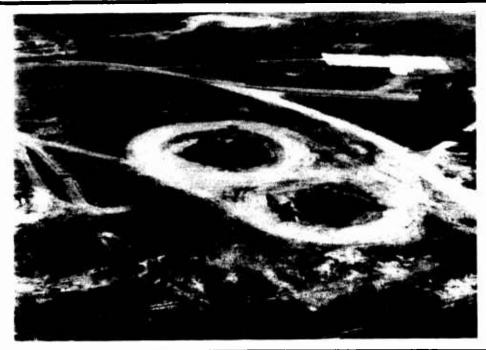
Aerial View of Active Fire Training Area (view facing east)

The two bentonite lined pits are visible, the inactive unlined pit (not shown) is located to the left.
